Contract #: 04-0120F4Cty: SF/ALA Rte: 80 PM: 13.2/13.9File #: 1.28**WELDING INSPECTION REPORT****Resident Engineer:** Casey, William**Address:** 333 Burma Road**City:** Oakland, CA 94607**Report No:** WIR-029290**Date Inspected:** 14-Mar-2013**Project Name:** SAS Superstructure**OSM Arrival Time:** 700**Prime Contractor:** American Bridge/Fluor Enterprises, a JV**OSM Departure Time:** 1730**Contractor:** American Bridge/Fluor Enterprises, a JV**Location:** Job site**CWI Name:** Andrew Keech**CWI Present:** Yes No**Inspected CWI report:** Yes No N/A**Rod Oven in Use:** Yes No N/A**Electrode to specification:** Yes No N/A**Weld Procedures Followed:** Yes No N/A**Qualified Welders:** Yes No N/A**Verified Joint Fit-up:** Yes No N/A**Approved Drawings:** Yes No N/A**Approved WPS:** Yes No N/A**Delayed / Cancelled:** Yes No N/A**Bridge No:** 34-0006**Component:** Tower**Summary of Items Observed:**

On this date, Quality Assurance Inspector (QAI) Robert A. DeArmond was present at the San Francisco Oakland bay Bridge job site at Yerba Buena Island to observe and perform Non-Destructive testing for the San Francisco Oakland Bay Bridge (SFOBB) project. This Quality Assurance Inspector (QAI)

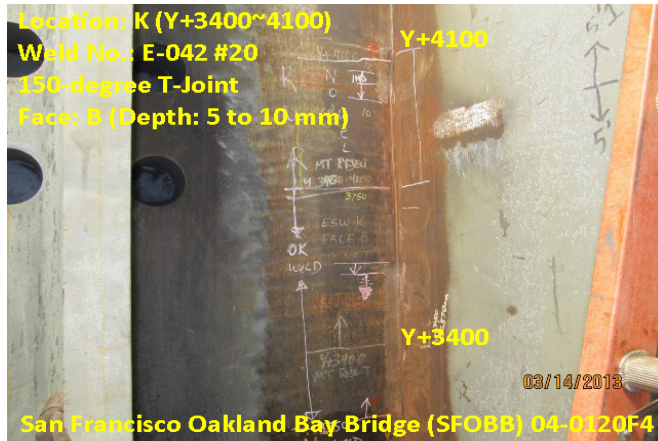
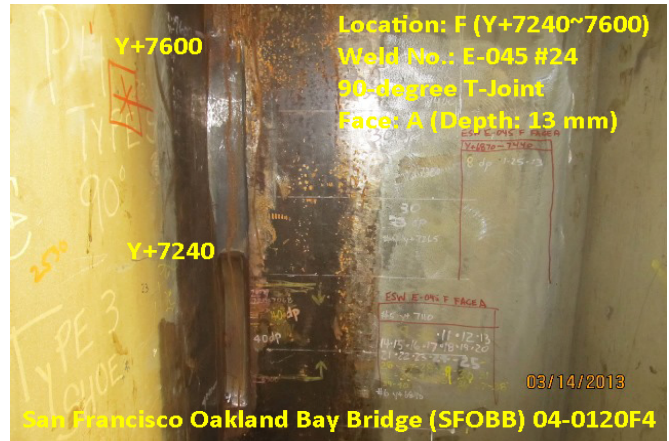
This QAI performed Ultrasonic Testing (UT), in tandem with ABF QC inspector Mr. Andrew Keech, on Complete Joint Penetration Electroslag welds. Weld joint is designated as a 60mm 150 degree T-Joint, Weld No.: E-042 #20 location K. During the QA/QC tandem Ultrasonic Testing, scanning was performed for longitudinal planar indications; in accordance with supplemental procedure SE-UT-D1.5-CT-108-ESW-R5. The UT inspection was performed using a 70 degree shear wave from face A; (2) planar recordable indications were discovered at locations noted below. The remaining length of weld tested with planar indications did not appear to have a rating that qualifies as rejectable or recordable according to AWS D1.5 2002 and supplemental procedure SE-UT-D1.5-CT-108-ESW-Revision: 5.

Planar Recordable Indication

Face A

Y+

1795 and 1815
